**Flood Control Project Maintenance
Levee Inspections**
LMA District Cover Sheet
Spring 2014 Levee Inspection Results

Reclamation District No. 2095 Paradise Cut

Waterway			Bank	Unit Miles
Unit No. 01 Paradise Cut			Left	1.45
	Spring (March - May)	Summer (June - August)	(September - November) Fall	Winter (December - February)
Unit Maintenance Rating (Fall Only)				
Date of Inspection	05/13/2014 - 05/13/2014			
DWR Inspector	Maksim Khashchuk			
Accompanied By	Rosie Silva RD2095

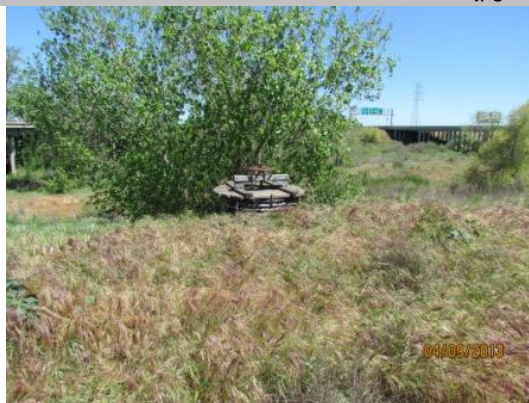
Photo 1 of 1 : mkhashch_s_20140428_00786.jpg

LM Start	0.07	Rating **	A/W	Issue No.	3
LM End	0.07	Issue Type +	En	Location *	WS
Category	Earthen Levee			GPS Latitude/Longitude	
				Start	End
Item	Encroachments			37.770572 °	37.770572 °
				-121.326283 °	-121.326283 °
DWR ID	DWR_RD2095_01_s _ 2013_3				
Action/Comments					
Pipe

View of the pipe at waterside levee hinge.

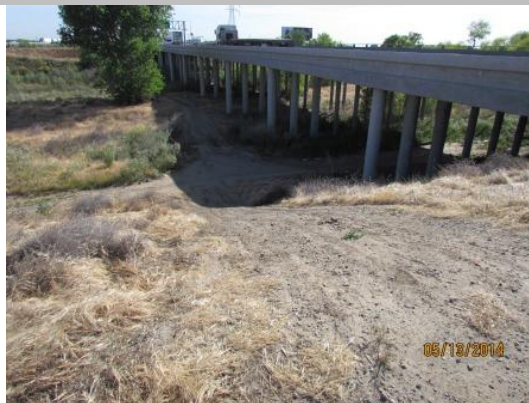
Photo 1 of 1 : mkhashch_s_20140519_01017.jpg

LM Start	0.11	Rating **	A/W	Issue No.	134
LM End	0.11	Issue Type +	Ma	Location *	WS
Category	Earthen Levee			GPS Latitude/Longitude	
				Start	End
Item	Slope Stability			37.770212 °	37.770212 °
				-121.325675 °	-121.325675 °
DWR ID	DWR_RD2095_01_s _ 2014_134				
Action/Comments					
Repair the levee slope damaged by vehicle traffic and prevent access where possible.

View of the vehicle access on the waterside levee slope.

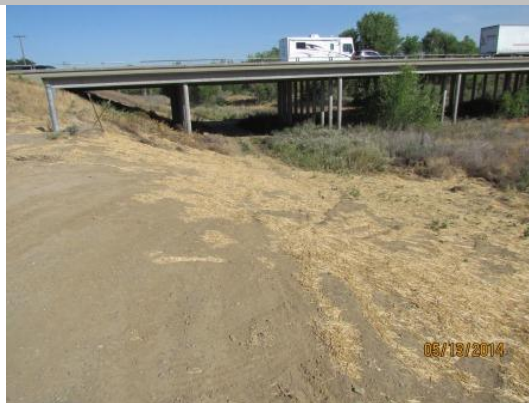
Photo 1 of 1 : mkhashch_s_20140519_01018.jpg

LM Start	0.15	Rating **	A/W	Issue No.	32
LM End	0.15	Issue Type +	Ma	Location *	WS
Category	Earthen Levee			GPS Latitude/Longitude	
				Start	End
Item	Slope Stability			37.769977 °	37.769977 °
				-121.325012 °	-121.325012 °
DWR ID	DWR_RD2095_01_s _ 2012_32				
Action/Comments					
Repair the levee slope damaged by vehicle traffic and prevent access where possible.					
Inspector Comments: LMA is actively controlling the slope instability.

View of the repaired waterside levee slope.

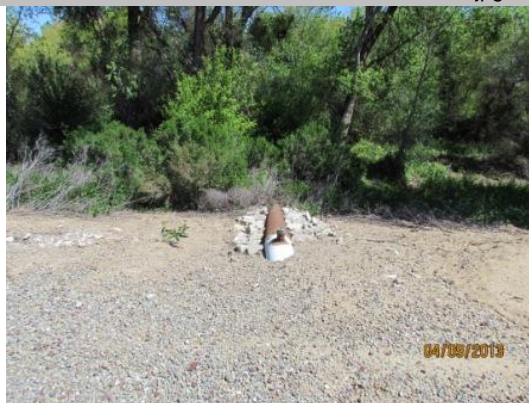
Photo 1 of 2 : mkhashch_s_20140428_00788.jpg

LM Start	0.35	Rating **	A/W	Issue No.	5
LM End	0.35	Issue Type +	En	Location *	CR
Category	Earthen Levee			GPS Latitude/Longitude	
				Start	End
Item	Encroachments			37.767822 °	37.767822 °
				-121.322835 °	-121.322835 °
DWR ID	DWR_RD2095_01_s _ 2012_5				
Action/Comments					
Pipe Inspector Comments: No closure devices or flap gate on discharge pipe. Pipe penetrates freeboard of levee.

View of the pipe penetrating waterside levee slope.

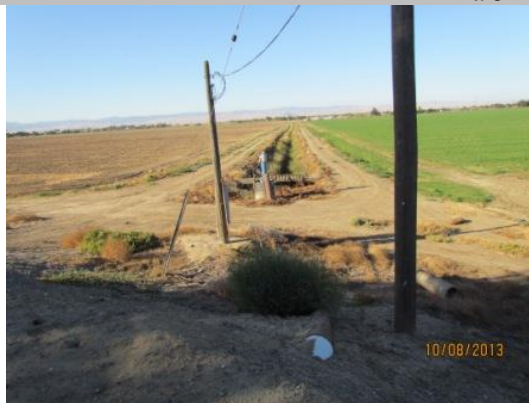
Photo 2 of 2 : mkhashch_s_20140428_00789.jpg

LM Start	0.35	Rating **	A/W	Issue No.	5 (cont)
LM End	0.35	Issue Type +	En	Location *	CR

View of pipe day lighting at landside levee slope.

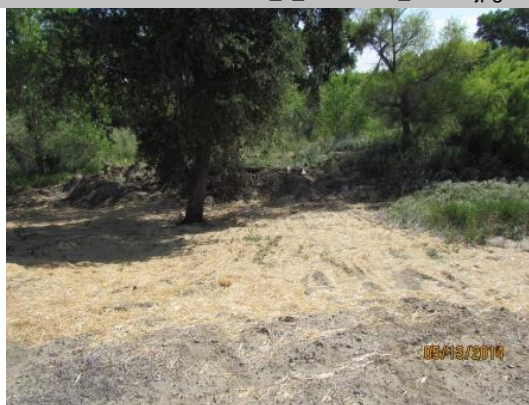
Photo 1 of 1 : mkhashch_s_20140519_01019.jpg

LM Start	0.42	Rating **	A/W	Issue No.	13
LM End	0.42	Issue Type +	Ma	Location *	WS
Category	Earthen Levee			GPS Latitude/Longitude	
				Start	End
Item	Slope Stability			37.766917 °	37.766917 °
				-121.322267 °	-121.322267 °
DWR ID	DWR_RD2095_01_s _ 2013_13				
Action/Comments					
Repair the levee slope damaged by vehicle traffic and prevent access

View of the repaired waterside levee slope.

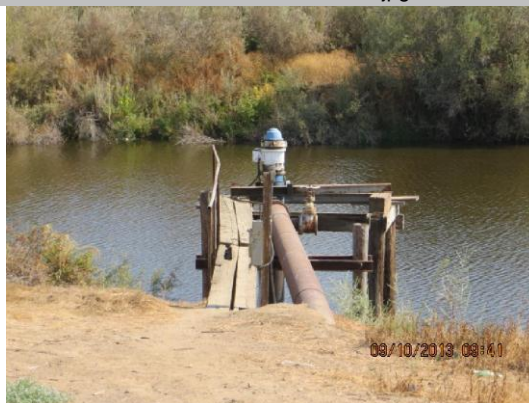
Photo 1 of 1 : UCIP_2116.jpg

LM Start	0.70	Rating **	M	Issue No.	129
LM End	0.70	Issue Type +	En	Location *	WS
Category	Supplemental			GPS Latitude/Longitude	
				Start	End
Item	DWR UCIP Field Study			37.763859 °	37.763859 °
				-121.319096 °	-121.319096 °
DWR ID	DWR_RD2095_01_s_2014_129				
Action/Comments					
Inspector Comments: FS_ID:19787					
EP_NO: N/A					
Repair Type:					
Crossing Status:					
UCIP Comments: Wooden walkway to pier possible safety hazard as wood planks are rotten. Positive closure device missing from distribution box on LS toe.					
FIELD_STRUCT_DESC: 16-inch steel irrigation pipe through the levee 8.0 feet below the crown. Pump on pile structure in the channel. 5'X5' concrete distribution box at the toe of the landward slope. Originally included in the 1964 O&M manual.					
FS Date: 9/10/2013

Pump on pier on WS toe.

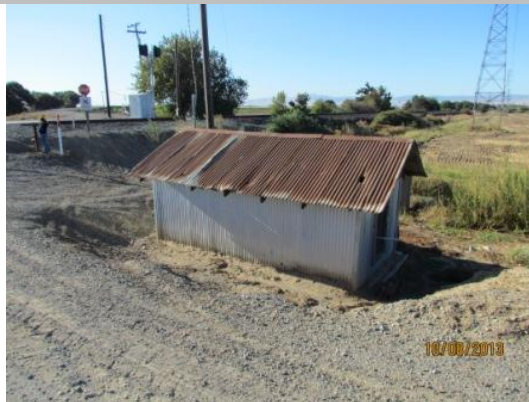
Photo 1 of 1 : mkhashch_s_20140428_00791.jpg

LM Start	0.70	Rating **	M	Issue No.	11
LM End	0.70	Issue Type +	En	Location *	LS
Category	Earthen Levee			GPS Latitude/Longitude	
				Start	End
Item	Encroachments			37.763630 °	37.763630 °
				-121.319045 °	-121.319045 °
DWR ID	DWR_RD2095_01_s_2012_11				
Action/Comments					
Building					
Inspector Comments: Pump house near RR.

View of building at the landside levee toe.

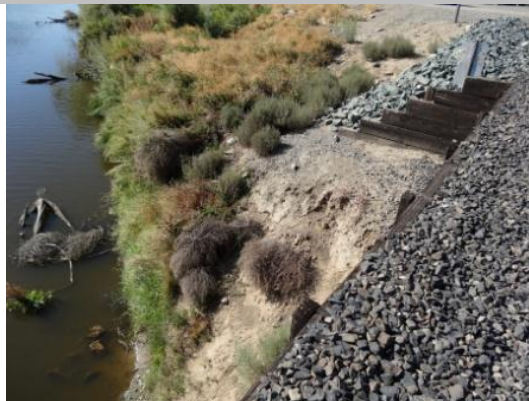
Photo 1 of 2 : mkhashch_s_20140428_00783.jpg

LM Start	0.73	Rating **	M	Issue No.	1
LM End	0.74	Issue Type +	Ma	Location *	WS
Category	Supplemental			GPS Latitude/Longitude	
				Start	End
Item	DWR Erosion Survey			37.763630 °	37.763630 °
				-121.319000 °	-121.319000 °
DWR ID	DWR_RD2095_01_s _ 2014_1				
Action/Comments					
Inspector Comments: 08/28/2013: No significant change observed. 07/18/2012: No significant changes observed. 09/02/2011: No significant changes observed. 09/22/2010: No significant changes observed. There is now considerable vegetation at the water line and along the lower berm slope. However, the erosion on the lower berm slope is still present and has not been corrected. 08/06/2010: Recommended for local maintenance issue, per CLRO. 07/29/2009: No major change since last visit; noticeable vegetation growth; erosion is on berm, but if left untreated, it will eventually erode into levee prism; site is recommended for annual assessment and monitoring of site, per CLRO CES 2008 Report; Site # is the same as RM6.80,LM0.73; previously rated "U". 07/22/2008: Downstream of WPRR near siphon pipe & pump; sandy levee; visited by Jeff Van Gilder and LRO in 2008 for repair assessment; scouring downstream of RR crossing, possibly caused by eddy effects. 03/13/2007: Site visited on 03/13/2007. [2013 Site ID:RD2095U01RM6.74]

Direct view of the erosion at the upstream of RR bridge.

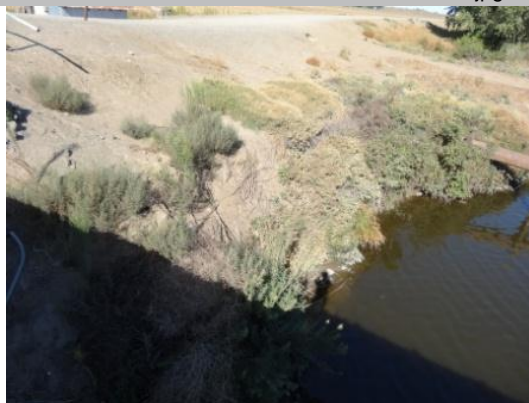
Photo 2 of 2 : mkhashch_s_20140428_00784.jpg

LM Start	0.73	Rating **	M	Issue No.	1 (cont)	
LM End	0.74	Issue Type +	Ma	Location *	WS	
Category	Supplemental			GPS Latitude/Longitude		
				Start	End	
Item	DWR Erosion Survey			37.763630 °	37.763630 °	
				-121.319000 °	-121.319000 °	
DWR ID	DWR_RD2095_01_s _ 2014_1					
Action/Comments						
Inspector Comments: 08/28/2013: No significant change observed. 07/18/2012: No significant changes observed. 09/02/2011: No significant changes observed. 09/22/2010: No significant changes observed. There is now considerable vegetation at the water line and along the lower berm slope. However, the erosion on the lower berm slope is still present and has not been corrected. 08/06/2010: Recommended for local maintenance issue, per CLRO. 07/29/2009: No major change since last visit; noticeable vegetation growth; erosion is on berm, but if left untreated, it will eventually erode into levee prism; site is recommended for annual assessment and monitoring of site, per CLRO CES 2008 Report; Site # is the same as RM6.80,LM0.73; previously rated "U". 07/22/2008: Downstream of WPRR near siphon pipe & pump; sandy levee; visited by Jeff Van Gilder and LRO in 2008 for repair assessment; scouring downstream of RR crossing, possibly caused by eddy effects. 03/13/2007: Site visited on 03/13/2007. [2013 Site ID:RD2095U01RM6.74]

Close view of the erosion downstream RR bridge.

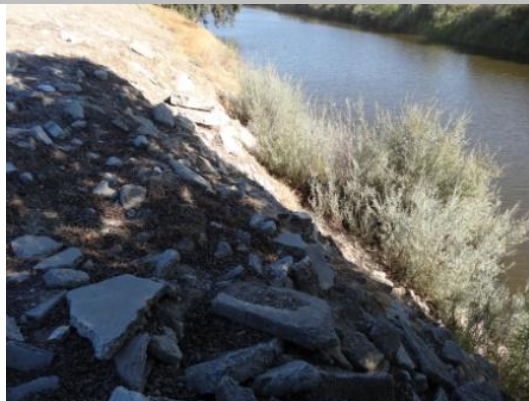
Photo 1 of 1 : mkhashch_s_20140428_00785.jpg

LM Start	0.86	Rating **	M	Issue No.	2
LM End	0.86	Issue Type +	Ma	Location *	WS
Category	Supplemental			GPS Latitude/Longitude	
				Start	End
Item	DWR Erosion Survey			37.761960 °	37.761960 °
				-121.318140 °	-121.318140 °
DWR ID	DWR_RD2095_01_s _ 2014_2				
Action/Comments					
Inspector Comments: 08/28/2013: No significant change observed. 07/18/2012: No significant change observed. 09/02/2011: No significant change observed. 09/22/2010: No significant change observed. Sloughing of the existing rip rap possibly due to a combination of steep slope and undesirable flood conditions. 08/06/2010: Recommended as local maintenance issue, per CLRO. 07/29/2009: No major change observed since last visit; near-vertical slope that has rip rap sloughing; site is recommended as a local maintenance issue, per CLRO CES Evaluation 2008 Report; Site # is the same as RM6.90,LM0.86; previously rated "U". 07/22/2008: Previous erosion site that is partially protected with concrete rubble; erosion scarp is adjacent to the sloughing rip rap. 03/13/2007: Site visited on 03/13/2007. [2013 Site ID:RD2095U01RM6.88]

Direct view of the site.

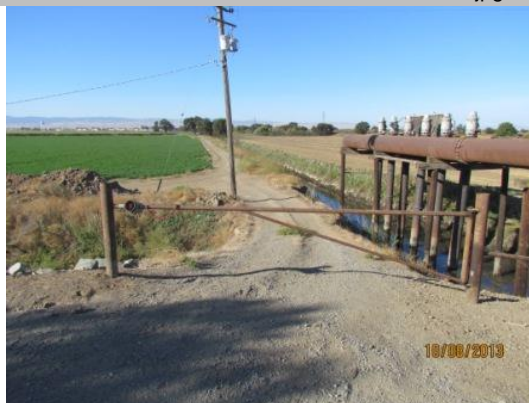
Photo 1 of 1 : mkhashch_s_20140428_00787.jpg

LM Start	0.87	Rating **	A/W	Issue No.	4
LM End	0.87	Issue Type +	En	Location *	LS
Category	Earthen Levee			GPS Latitude/Longitude	
				Start	End
Item	Encroachments			37.761475 °	37.761475 °
				-121.317804 °	-121.317804 °
DWR ID	DWR_RD2095_01_f _ 2013_4				
Action/Comments					
Fence Inspector Comments: Unpermitted gate across landside levee ramp. District is in process of submitting an application for a permit from CVFPB. A key was provided to the DWR inspector.

View of the new gate at landside levee hinge.

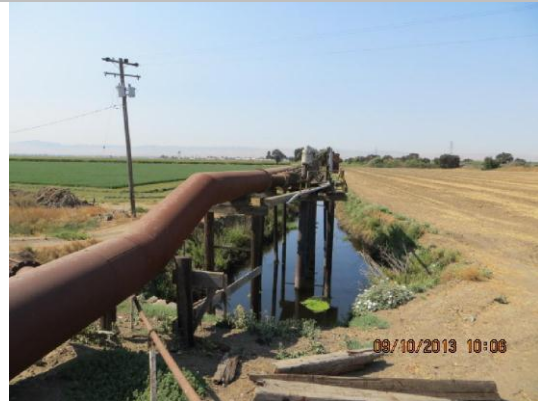
Photo 1 of 1 : UCIP_2123.jpg

Inspector Comments: FS_ID:19812
 EP_NO: 13926
 Repair Type:
 Crossing Status:
 UCIP Comments: No electrical connection can be identified. Possibly awaiting a flood event for re-activation.
 FIELD_STRUCT_DESC: 40-inch steel stormdrain discharge pipe through the levee 1-foot below the crown. 6 pumps mounted on wooden pier at LS toe, all discharge into 40-inch pipe. Permit was for a 24-inch steel discharge pipe through levee 2.0 feet below crown with a flapgate on waterward side. But, Permit notes show it was modified in 2001 to its current status (Permit No. 13926).
 FS Date: 9/10/2013

Pumps on pier at LS toe. Note electrical conduit without connection on right side of pier.

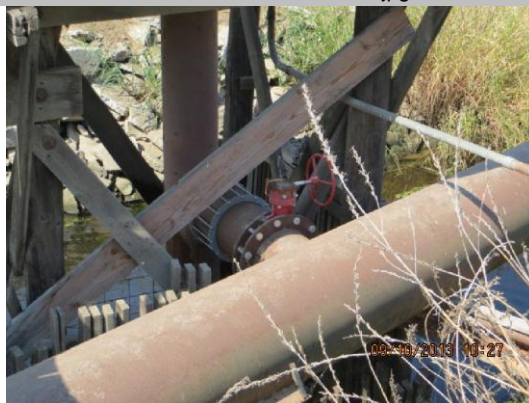
Photo 1 of 1 : UCIP_2129.jpg

LM Start	0.91	Rating **	M	Issue No.	132
LM End	0.91	Issue Type +	En	Location *	LS
Category	Supplemental			GPS Latitude/Longitude	
				Start	End
Item	DWR UCIP Field Study			37.761079 °	37.761079 °
				-121.317566 °	-121.317566 °
DWR ID	DWR_RD2095_01_s _ 2014_132				
Action/Comments					
Inspector Comments: FS_ID:19815					
EP_NO: N/A					
Repair Type:					
Crossing Status:					
UCIP Comments: Pipe abandoned and should be verified as having been done so properly.					
FIELD_STRUCT_DESC: 12-inch steel stormdrain pipe through the levee 1.5 feet below the crown. Pump on pile structure in drain ditch on landward side. Siphon breaker in steel standpipe on the waterward slope. Originally included in the 1964 O&M manual.					
FS Date: 9/10/2013

Possible location of 12-inch pipe connection to pump on LS toe.

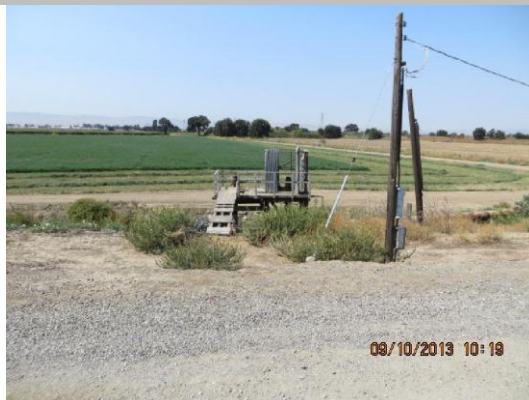
Photo 1 of 1 : UCIP_2126.jpg

LM Start	0.92	Rating **	M	Issue No.	133
LM End	0.92	Issue Type +	En	Location *	LS
Category	Supplemental			GPS Latitude/Longitude	
				Start	End
Item	DWR UCIP Field Study			37.761046 °	37.761046 °
				-121.317539 °	-121.317539 °
DWR ID	DWR_RD2095_01_s _ 2014_133				
Action/Comments					
Inspector Comments: FS_ID:19813					
EP_NO: 6537					
Repair Type:					
Crossing Status:					
UCIP Comments: Corroded holes on pipe at outlet WS toe, good indication of internal pipe condition. Good candidate for video inspection.					
FIELD_STRUCT_DESC: 14-inch steel stormdrain discharge pipe through the levee 2.5 feet below the crown. Pump on pile structure in drain ditch on landward side. Siphon breaker in 24-inch CMP riser on the waterward shoulder and flap gate on the waterward end (Permit No. 6537, 1969).					
FS Date: 9/10/2013

Pump on wooden pier at LS toe.

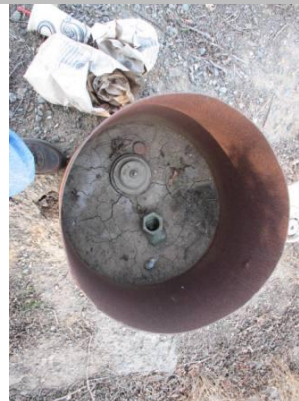
Photo 1 of 1 : mkhashch_s_20140428_00796.jpg

LM Start	0.92	Rating **	A/W	Issue No.	18
LM End	0.92	Issue Type +	En	Location *	LS
Category	Earthen Levee			GPS Latitude/Longitude	
				Start	End
Item	Encroachments			37.760792 °	37.760792 °
				-121.317705 °	-121.317705 °
DWR ID	DWR_RD2095_01_s _ 2012_18				
Action/Comments					
Pipe					
Inspector Comments: Pipe on south is connected with siphon breaker at hinge point.

11/01/2011 Siphon breaker at hinge point on waterside.

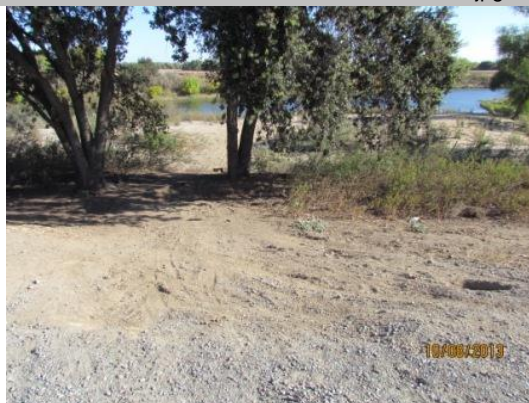
Photo 1 of 1 : mkhashch_s_20140428_00806.jpg

LM Start	0.03	Rating **	A/W	Issue No.	9
LM End	0.03	Issue Type +	Ma	Location *	WS
Category	Earthen Levee			GPS Latitude/Longitude	
				Start	End
Item	Slope Stability			37.758986 °	37.758986 °
				-121.307854 °	-121.307854 °
DWR ID	DWR_RD2095_02_s _ 2013_9				
Action/Comments					
Repair the levee slope damaged by vehicle traffic and prevent access where possible.

View of the vehicle tire ruts on waterside levee slope.

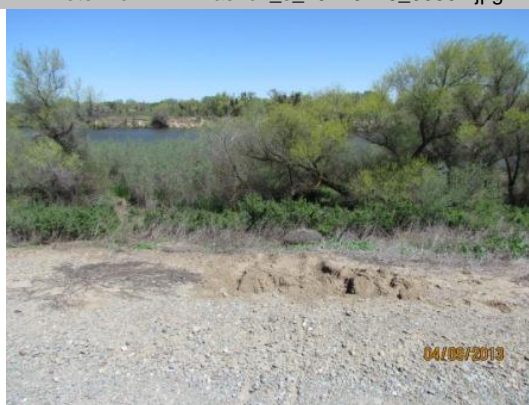
Photo 1 of 1 : mkhashch_s_20140428_00807.jpg

LM Start	0.18	Rating **	A/W	Issue No.	10
LM End	0.18	Issue Type +	Ma	Location *	WS
Category	Earthen Levee			GPS Latitude/Longitude	
				Start	End
Item	Slope Stability			37.757322 °	37.757322 °
				-121.306291 °	-121.306291 °
DWR ID	DWR_RD2095_02_s _ 2013_10				
Action/Comments					
Repair the levee slope damaged by vehicle traffic and prevent access where possible.

View of the vehicle tire ruts on waterside levee slope.

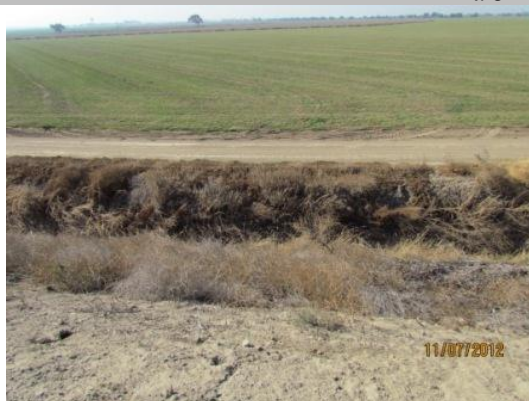
Photo 1 of 1 : mkhashch_s_20140428_00804.jpg

LM Start	0.36	Rating **	M	Issue No.	5
LM End	0.85	Issue Type +	En	Location *	LS
Category	Earthen Levee			GPS Latitude/Longitude	
				Start	End
Item	Encroachments			37.754952 °	37.749645 °
				-121.305880 °	-121.301977 °
DWR ID	DWR_RD2095_02_f _ 2012_5				
Action/Comments					
Ditch

View of ditch along landside toe.

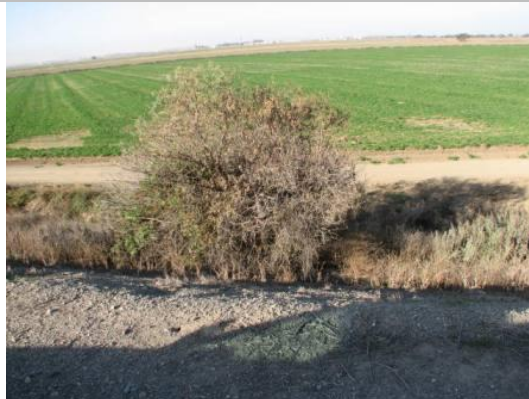
Photo 1 of 1 : mkhashch_s_20140428_00805.jpg

LM Start	0.62	Rating **	A/W	Issue No.	6
LM End	0.62	Issue Type +	Ma	Location *	LS
Category	Earthen Levee			GPS Latitude/Longitude	
				Start	End
Item	Vegetation			37.751668 °	37.751668 °
				-121.304302 °	-121.304302 °
DWR ID	DWR_RD2095_02_s_2012_6				
Action/Comments					
Elderberries are blocking visibility and flood fight capability.

11/01/2011 Elderberry bush at landside toe.

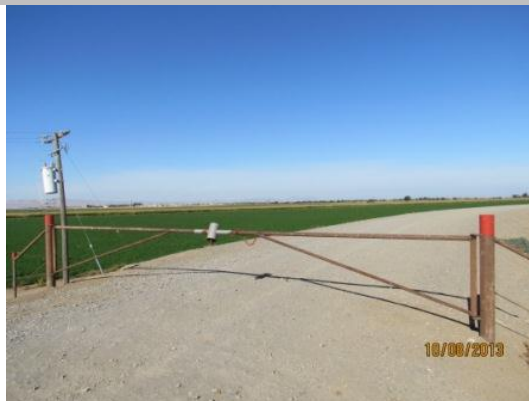
Photo 1 of 1 : mkhashch_s_20140428_00808.jpg

LM Start	0.75	Rating **	A/W	Issue No.	14
LM End	0.75	Issue Type +	En	Location *	CR
Category	Earthen Levee			GPS Latitude/Longitude	
				Start	End
Item	Encroachments			37.749916 °	37.749916 °
				-121.303312 °	-121.303312 °
DWR ID	DWR_RD2095_02_f_2013_14				
Action/Comments					
Fence Inspector Comments: Unpermitted gate across levee crown. District has submitted an application for a permit from CVFPB. A key was provided to DWR inspector.

View of new gate across levee crown.

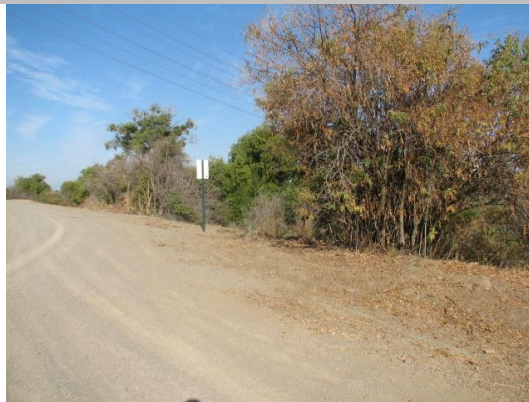
Photo 1 of 1 : mkhashch_s_20140428_00811.jpg

LM Start	1.01	Rating **	U	Issue No.	941
LM End	1.01	Issue Type +	Ma	Location *	WS
Category	Earthen Levee			GPS Latitude/Longitude	
				Start	End
Item	Vegetation			37.749650 °	37.749650 °
				-121.299362 °	-121.299362 °
DWR ID	DWR_RD2095_02_s _ 2012_941				
Action/Comments					
Elderberries are blocking visibility and flood fight capability. Inspector Comments: Dense bush within 20' of crown on waterside slope.

Elderberry blocks visibility of levee slope.

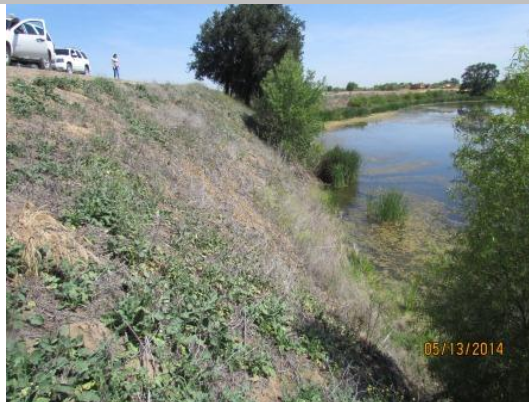
Photo 1 of 1 : mkhashch_s_20140519_01020.jpg

LM Start	1.35	Rating **	A/W	Issue No.	195
LM End	1.35	Issue Type +	Ma	Location *	WS
Category	Earthen Levee			GPS Latitude/Longitude	
				Start	End
Item	Erosion / Bank Caving			37.744746 °	37.744746 °
				-121.297695 °	-121.297695 °
DWR ID	DWR_RD2095_02_s _ 2014_195				
Action/Comments					
Note and monitor erosion site.

View of the erosion on the waterside levee slope possibly eroding into the levee prism.

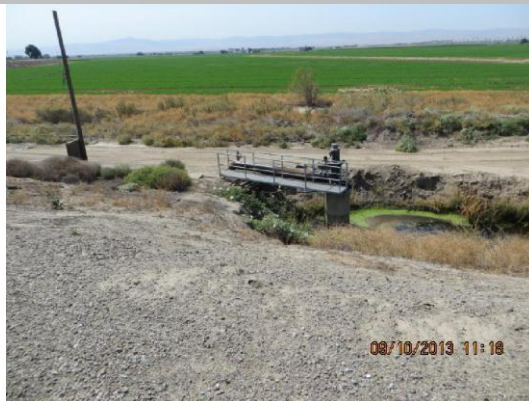
Photo 1 of 1 : UCIP_2140.jpg

LM Start	1.50	Rating **	M	Issue No.	192
LM End	1.50	Issue Type +	En	Location *	WS
Category	Supplemental			GPS Latitude/Longitude	
				Start	End
Item	DWR UCIP Field Study			37.743142 °	37.743142 °
				-121.297692 °	-121.297692 °
DWR ID	DWR_RD2095_02_s _ 2014_192				
Action/Comments					
Inspector Comments: FS_ID:19863					
EP_NO: 4658					
Repair Type:					
Crossing Status:					
UCIP Comments: Pipe appears abandoned in place and re-routed to					
LM 1.652. Need to verify pipe was properly abandoned. Permit					
FIELD_STRUCT_DESC: *Abandoned* 14-inch pipe through levee 3.5-					
feet below crown. Pump on structure over drain ditch on the landward					
side. Flap gate on the waterward end (Permit No. 4658). Originally					
included in the 1968 O&M manual.					
FS Date: 9/10/2013

Pump visible on LS toe, but pipe has been re-routed to southwest.

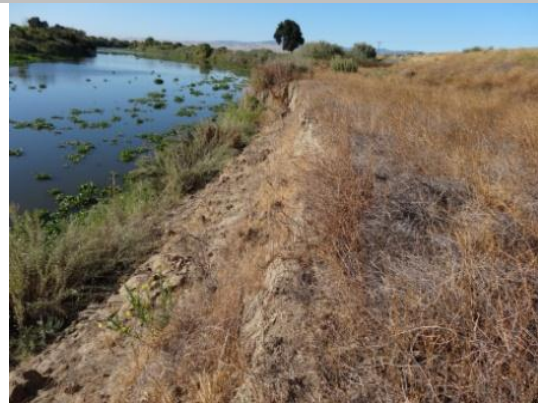
Photo 1 of 1 : mkhashch_s_20140428_00802.jpg

LM Start	1.77	Rating **	M	Issue No.	1
LM End	1.80	Issue Type +	Ma	Location *	WS
Category	Supplemental			GPS Latitude/Longitude	
				Start	End
Item	DWR Erosion Survey			37.740196 °	37.740196 °
				-121.297662 °	-121.297662 °
DWR ID	DWR_RD2095_02_s _ 2014_1				
Action/Comments					
Inspector Comments: 08/28/2013: No significant change observed. 09/13/2012: The site has been visited by land survey. The vegetation on the site shows the erosion has not developed significantly from the last survey. The site was not visited by boat survey due to the limitation of navigable waterway. 08/23/2011: No significant changes observed. 9/22/2010: No significant changes observed. There is moderate vegetation growth on the berm. Despite the erosion occurring on the berm, corrective action should be taken before the issue becomes severe. 9/29/2009: Site is immediately downstream of a section of existing rip rap; there is a 20-foot berm remaining; berm will continue to erode unless erosion is mitigated; Site# is the same as RM62.6, LM1.87; recommended for annual assessment, per CES Evaluation 2008 Report 2006: Visited 10/20/06 [2013 Site ID:RD2095U02RM60.62]

Looking at the erosion.

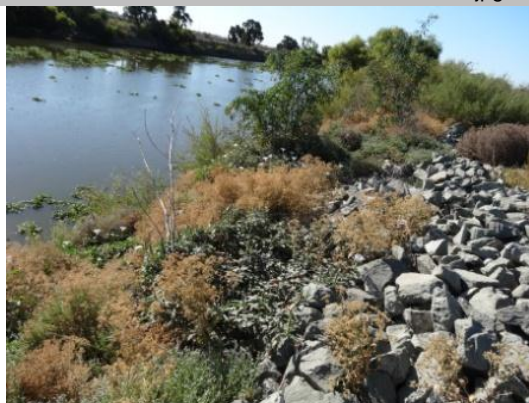
Photo 1 of 1 : mkhashch_s_20140428_00803.jpg

Inspector Comments: 08/28/2013: No significant change observed. Dense vegetation blocks the visual inspection at the site.
 09/13/2012: The site has been visited by land survey. The erosion is not visible from the levee slope because of dense vegetation at the site. Levee slope is protected by placed rocks. The site was not visited by boat survey due to the limitation of navigable waterway.
 08/23/2011: Dense vegetation makes it difficult to view the possible erosion. No new development was observed on site.
 09/23/2010: At the time of the inspection, the erosion site was difficult to view from the levee. Erosion is located on the bank toe, below the existing rip rap. There were no signs of repair on site, nor has the site been reported to be repaired by the district. Images taken from last year indicate that existing rip rap at the bank toe has sloughed exposing the underlying soils. Weakening of the toe could lead to future bank instability.

08/05/2010: Recommended for annual assessment and monitoring during flood events, per CLRO.
 09/29/2009: No major change observed since last visit; sloughing of the rip rap above toe; erosion begins immediately downstream of existing rip rap revetment; roughly 15-foot berm remains; however, it will continue to erode and eventually intrude into the levee profile if left untreated.
 10/20/2006: Just upstream of where berm starts to widen. [2013 Site ID:RD2095U02RM60.69]

Direct view of the erosion.

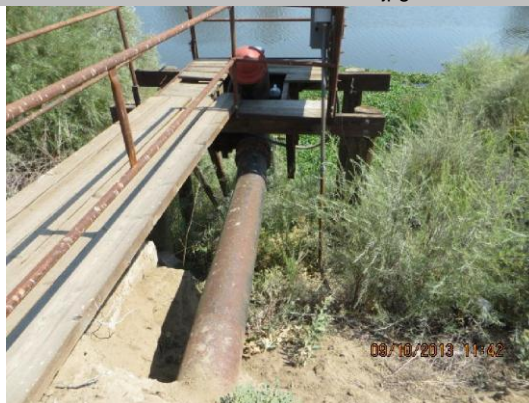
Photo 1 of 1 : UCIP_2148.jpg

LM Start	2.11	Rating **	M	Issue No.	194
LM End	2.11	Issue Type +	En	Location *	WS
Category	Supplemental			GPS Latitude/Longitude	
				Start	End
Item	DWR UCIP Field Study			37.735415 °	37.735415 °
				-121.297859 °	-121.297859 °
DWR ID	DWR_RD2095_02_s_2014_194				
Action/Comments					
Inspector Comments: FS_ID:19867					
EP_NO: N/A					
Repair Type:					
Crossing Status:					
UCIP Comments: Siphon breaker on LS shoulder does not appear to be functional.					
FIELD_STRUCT_DESC: 16-inch steel irrigation pipe through the levee 2.0-feet below the crown. Slant pump on steel platform on WS slope. Siphon breaker on the landward shoulder marked by T-post. Service pole and meter on the landward toe. Possible concrete standpipe on LS toe. Originally included in the 1968 O&M manual.					
FS Date: 9/10/2013

Slant pump on metal pier at WS toe.

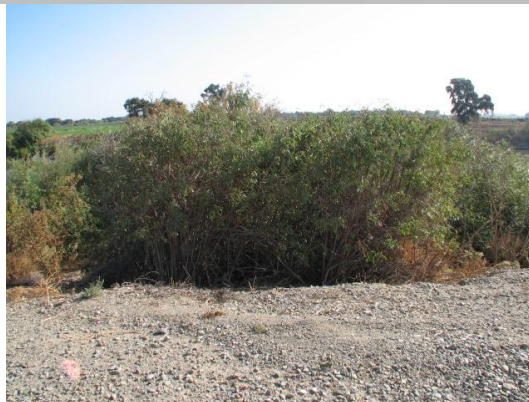
Photo 1 of 1 : mkhashch_s_20140428_00810.jpg

LM Start	2.14	Rating **	M	Issue No.	20
LM End	2.14	Issue Type +	Ma	Location *	WS
Category	Earthen Levee			GPS Latitude/Longitude	
				Start	End
Item	Vegetation			37.734858 °	37.734858 °
				-121.297758 °	-121.297758 °
DWR ID	DWR_RD2095_02_s_2012_20				
Action/Comments					
Elderberries are blocking visibility and flood fight capability.

Vegetation on waterside slope obstructs access and visibility.

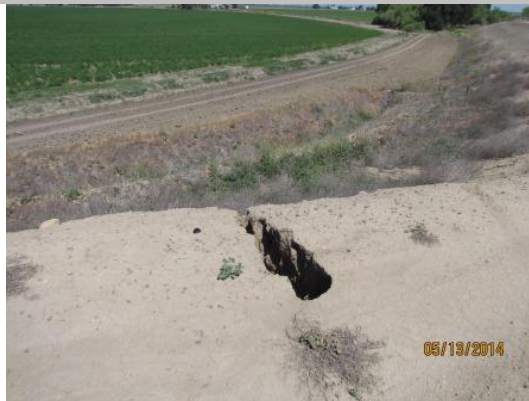
Photo 1 of 1 : mkhashch_s_20140519_01021.jpg

LM Start	2.88	Rating **	M	Issue No.	15
LM End	2.88	Issue Type +	Ma	Location *	LS
Category	Earthen Levee			GPS Latitude/Longitude	
				Start	End
Item	Erosion / Bank Caving			37.724633 °	37.724633 °
				-121.299732 °	-121.299732 °
DWR ID	DWR_RD2095_02_s _ 2014_15				
Action/Comments					
Schedule repair of erosion site prior to the next inspection.

View of the erosion on the landside levee slope and hinge.

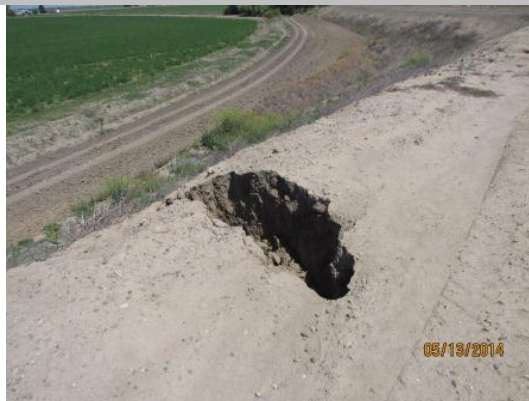
Photo 1 of 1 : mkhashch_s_20140519_01022.jpg

LM Start	2.89	Rating **	M	Issue No.	19
LM End	2.89	Issue Type +	Ma	Location *	LS
Category	Earthen Levee			GPS Latitude/Longitude	
				Start	End
Item	Erosion / Bank Caving			37.724435 °	37.724435 °
				-121.299868 °	-121.299868 °
DWR ID	DWR_RD2095_02_s _ 2014_19				
Action/Comments					
Schedule repair of erosion site prior to the next inspection.

View of the erosion on the landside levee hinge and slope.

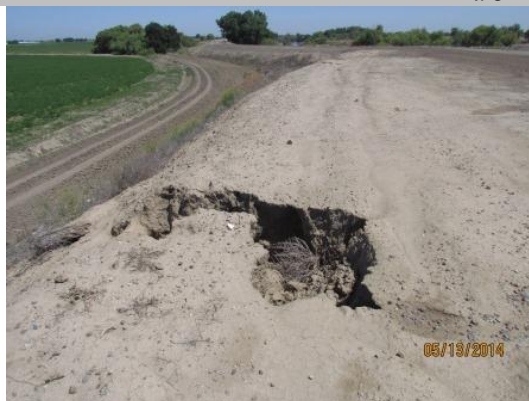
Photo 1 of 1 : mkhashch_s_20140519_01023.jpg

LM Start	2.91	Rating **	M	Issue No.	196
LM End	2.91	Issue Type +	Ma	Location *	LS
Category	Earthen Levee			GPS Latitude/Longitude	
				Start	End
Item	Erosion / Bank Caving			37.724246 °	37.724246 °
				-121.299997 °	-121.299997 °
DWR ID	DWR_RD2095_02_s _ 2014_196				
Action/Comments					
Schedule repair of erosion site prior to the next inspection.

View of the erosion on the landside levee hinge and slope.
